# Veterans Administration Hospital (44)

13000 Sayre Street, Los Angeles County

**ROY G. JOHNSTON**

*Brandow & Johnston Associates  
Los Angeles, Calif.*

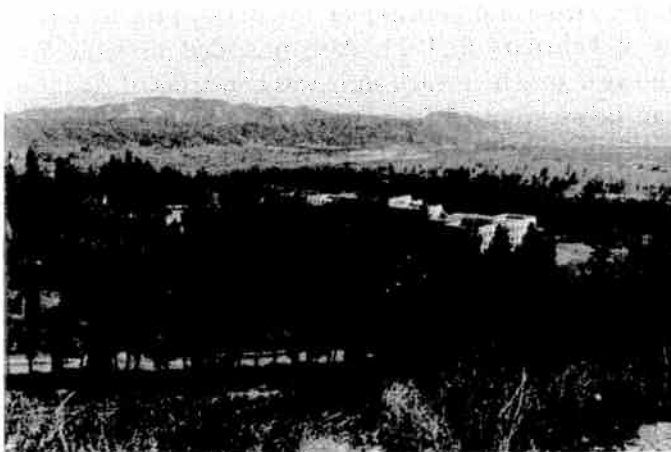
Figure 2.—Veterans Administration Hospital. View toward southeast from adjacent hillside with unit 43 in center.

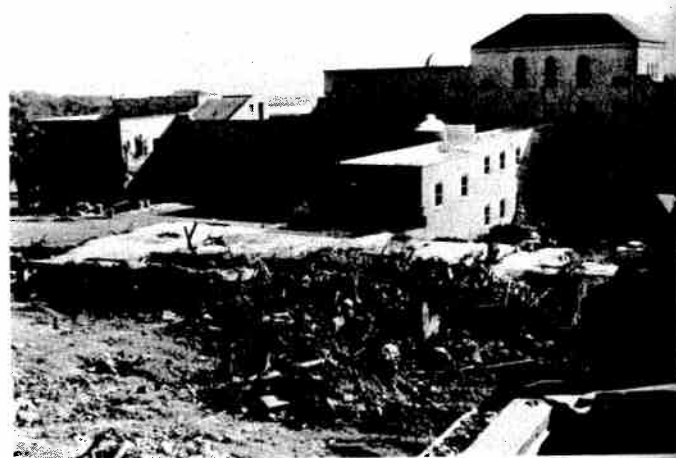
Unit identification number	Year constructed	Structural classification type	Inspection observations
1.....	1925...	I.....	Building had totally collapsed and debris has been removed (fig. 3).
2(a)....	1925...	I.....	Building had totally collapsed and debris has been removed (figs. 4, 5, and 6).
2(b)....	1950...	II.....	Frame was essentially intact. Exterior walls had diagonal hairline cracks. Chimneys from unit 2(a) had collapsed onto unit 2(b) and damaged east portion of roof. 1- to 3-inch downward displacement of adjacent grade was observed on north and west sides (figs. 4, 5, and 6).

Figure 3.—Veterans Administration Hospital, Unit 1, remaining debris. North elevation of unit 43 in background.

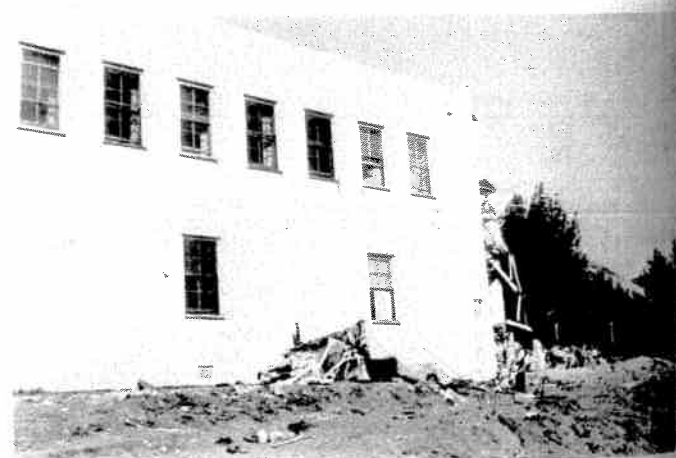
Figure 4.—Veterans Administration Hospital, Unit 2(b). South elevation with remains of unit 2(a) at far right.

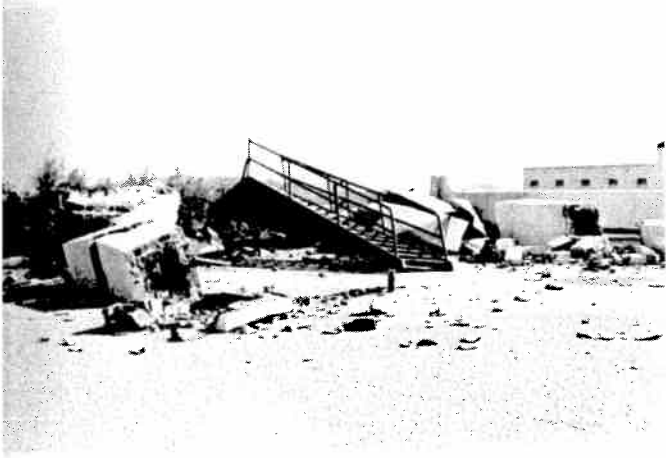
Figure 5.—Veterans Administration Hospital. Chimneys from unit 2(a) collapsed onto east end of unit 2(b) roof.

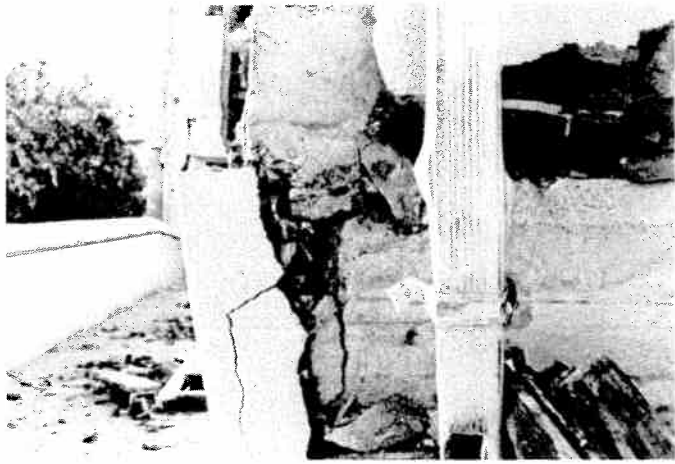
Figure 8.—Veterans Administration Hospital. Unit 3. Southeast corner column at first floor.

3.....	1925...	I.....	Frame was standing, but several columns were fractured, spalled, and displaced horizontally. Portions of walls were collapsed and others had large fractures. 1- to 5-inch downward displacement of adjacent grade was observed on north and west sides (figs. 7 and 8).

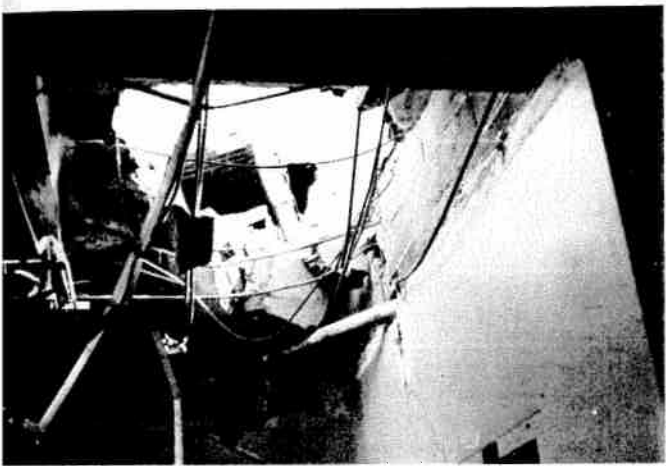
Figure 6.—Veterans Administration Hospital. Unit 2(b). Inside, looking up toward collapsed chimneys (see fig. 5).

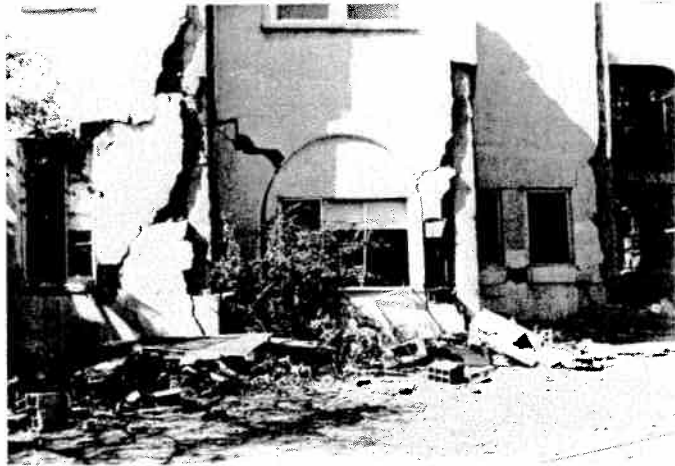
Figure 9.—Veterans Administration Hospital. Unit 5. East elevation.

4.....	1925...	I.....	Frame was standing, but portions of walls were collapsed and others had large fractures and cracks.
5.....	1925...	I.....	Frame was essentially intact. Walls had large fractures (fig. 9).

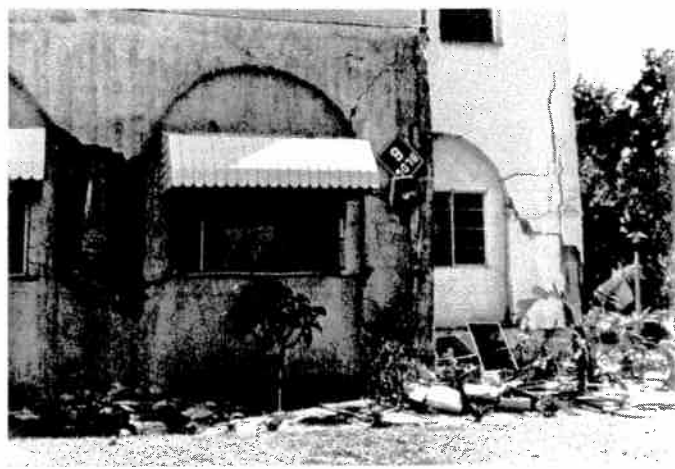
Figure 10.—Veterans Administration Hospital. Unit 6. West elevation.

6.....	1925...	I.....	Frame was standing, but several columns were fractured, spalled, and displaced horizontally. Portions of walls were collapsed and others had large fractures (fig. 10).

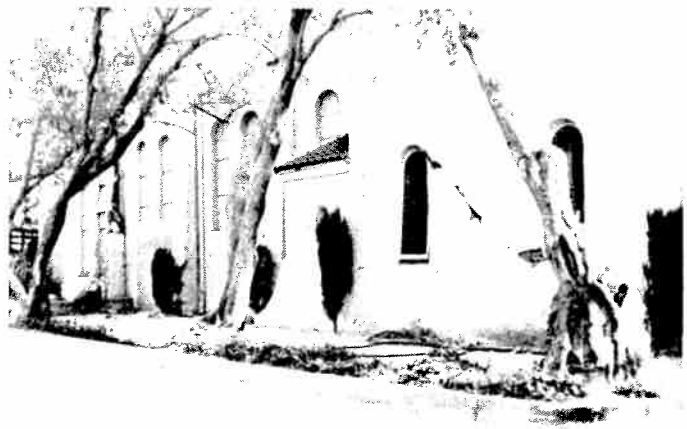
Figure 11.—Veterans Administration Hospital. Unit 7.  
North elevation of north wing.

7.....	1925...	I.....	Frame is essentially intact. Chimneys had collapsed onto roof. Ground floor had several 1/16-inch-wide cracks. Basement floor had several 1/8-inch-wide cracks and one 1 1/2-inch upward displacement. Exterior and basement walls had diagonal cracks. Interior walls had large fractures (fig. 11).

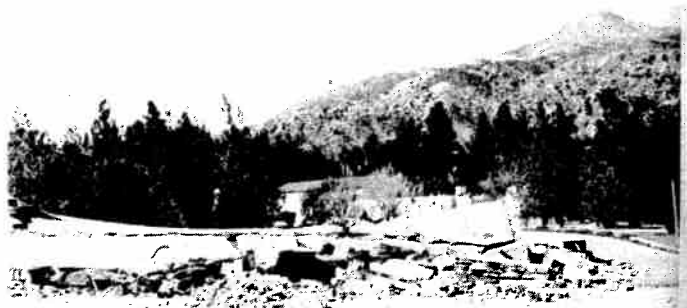
Figure 12.—Veterans Administration Hospital. Unit 8.  
East elevation

8.....	1925...	I.....	Building was totally collapsed (fig. 12).
9.....	1925...	I.....	Frame was partially collapsed and several remaining columns were fractured, spalled, and displaced horizontally. Portions of walls were collapsed and others had large fractures (fig. 13).

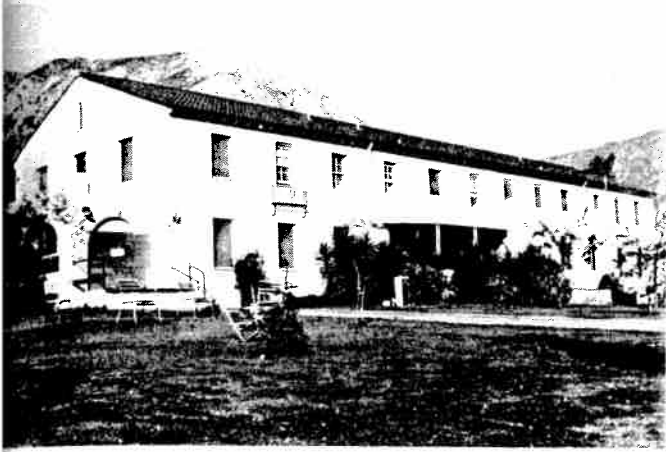
Figure 14.—Veterans Administration Hospital, Unit 11.  
South elevation.

10.....	1925...	I.....	Building was totally collapsed.
11(a)...	1925...	I.....	Frame was essentially intact. Chimneys were collapsed. Exterior walls had continuous horizontal cracks at floor- and rooflines. Portions of interior walls were collapsed and others had large fractures (fig. 14).
11(b)...	1929...	I.....	Frame was essentially intact. South exterior wall had continuous horizontal crack at roofline. North exterior wall had continuous horizontal crack at floorline. Interior walls had cracks from 1/8 inch to 1 inch in width (fig. 14).

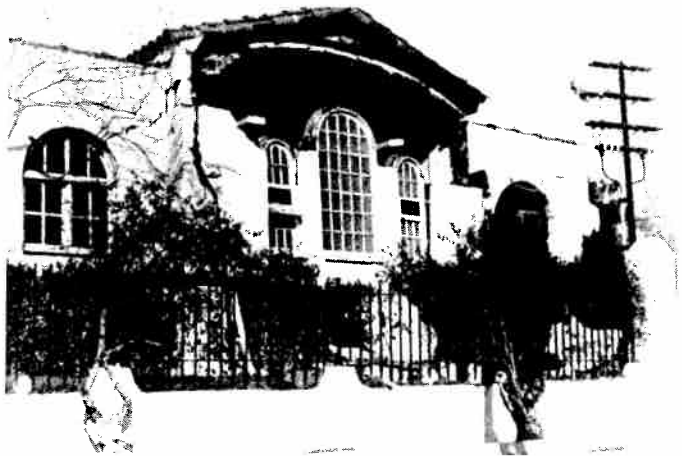
Figure 17.—Veterans Administration Hospital, Unit 19.  
South elevation.

19.....	1925...	III.....	Frame was standing, but portions of walls were collapsed and others had large fractures (fig. 17).
20.....	1925...	Metal tank.	Tank was essentially intact. Looking north, steel I-beam supports had rotated 90° counterclockwise. Tank was displaced about 4 inches in a west direction. Anchor bolts were deformed. Foundations were fractured and displaced 4 to 6 inches vertically (fig. 18).

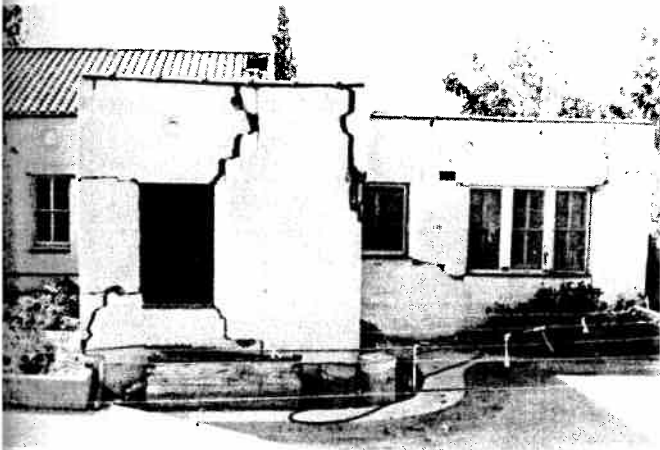
Figure 15.—Veterans Administration Hospital, Unit 13.  
North elevation.

Unit identification number	Year constructed	Structural classification type	Inspection observations
13.....	1925...	III.....	Frame was standing, but portions of exterior walls were collapsed and others had large fractures with horizontal displacements (fig. 15).

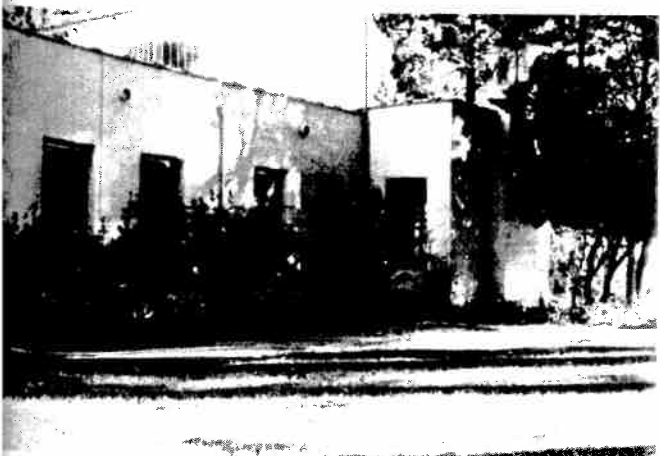
Figure 16.—Veterans Administration Hospital, Unit 18.  
North elevation.

18.....	1925...	III.....	Frame was essentially intact, but some exterior walls had cracks up to 1/8 inch in width. Chimney was fractured at roofline (fig. 16).

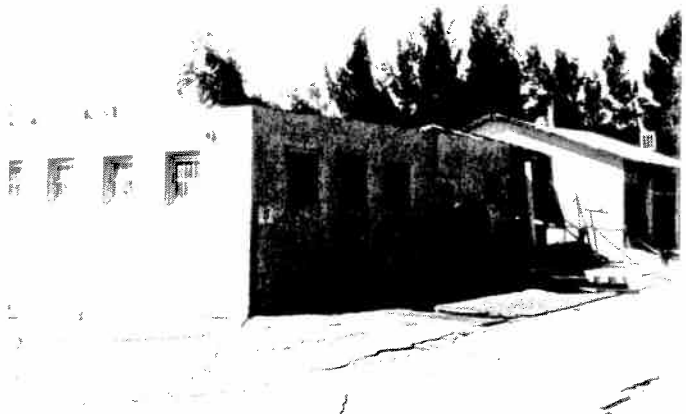
Figure 19.—Veterans Administration Hospital, Unit 23.  
East elevation.

23.....	1931...	IV.....	Frame was essentially intact. Exterior walls had continuous horizontal cracks at floorline. 2-inch downward displacement of adjacent grade was observed on north side (fig. 19).

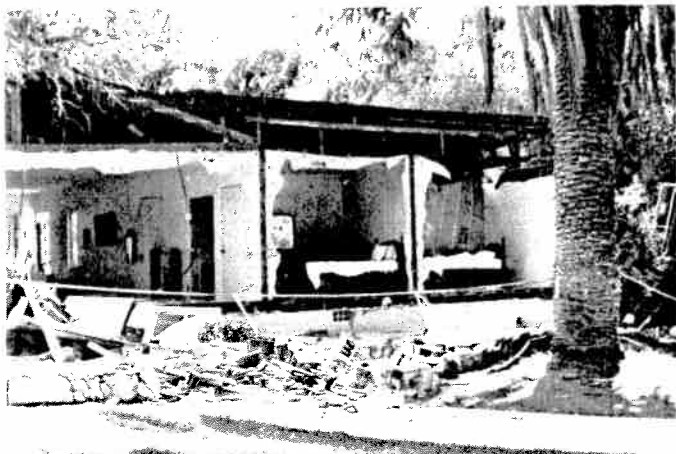
*Figure 20.—Veterans Administration Hospital. Unit 28. West elevation.*

28.....	1928...	III.....	Frame was standing, but majority of exterior walls were collapsed (fig. 20).
29.....	1930...	II.....	Frame was essentially intact with no apparent damage. Wood frame canopy between units 26 and 29 was collapsed (fig. 21).

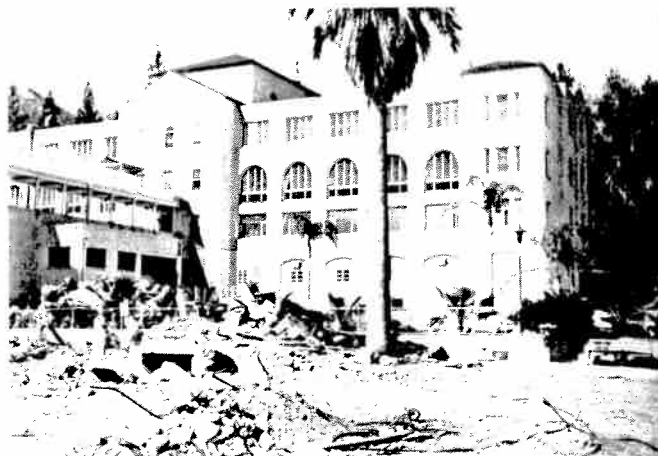
41.....	1938...	II.....	Frame was essentially intact. Some walls had diagonal hairline cracks. Basement slab-on-grade had 1/16-inch-wide continuous crack running parallel to and 6 feet south of north exterior wall. 1- to 3-inch downward displacement of adjacent grade was observed on north and west sides (fig. 23).

*Figure 23.—Veterans Administration Hospital. Unit 41. South elevation with remaining debris of unit 2(a) in foreground.*

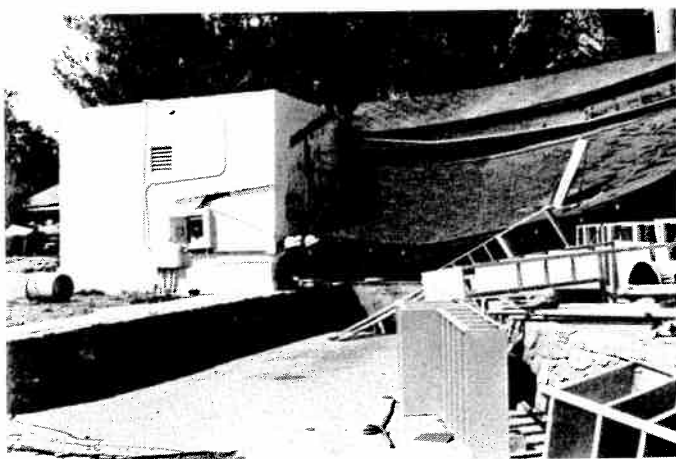
*Figure 21.—Veterans Administration Hospital. Unit 29. East elevation, showing collapsed canopy between units 29 and 26.*

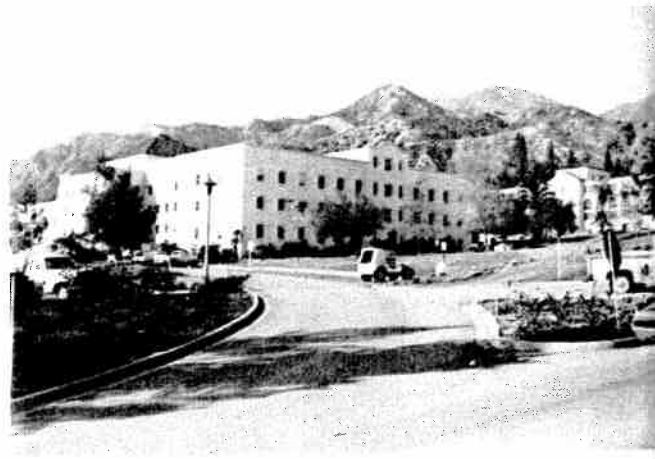
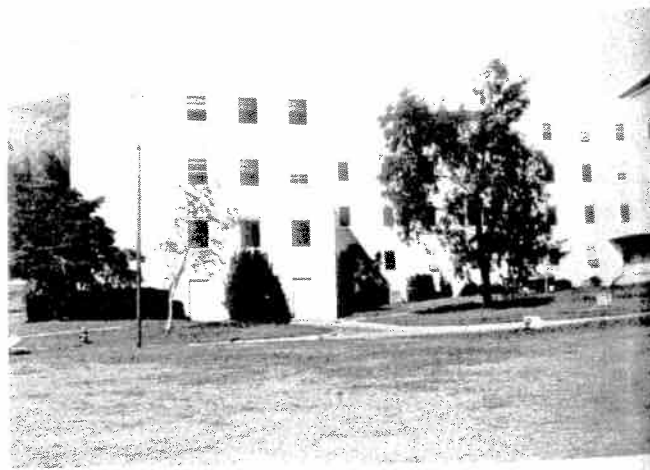
42.....	1940...	III.....	Frame was essentially intact. Walls had diagonal cracks up to 1/8 inch in width.
43.....	1949...	II.....	Frame was essentially intact. Some walls had diagonal hairline cracks (figs. 24 and 25).

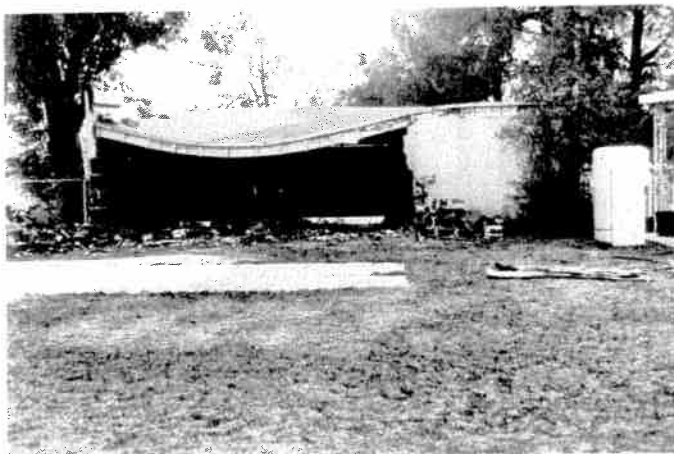
*Figure 22.—Veterans Administration Hospital. Unit 33. North elevation.*

33.....	1939...	III.....	Frame was standing, but large portion of roof was collapsed and most of north wall was collapsed (fig. 22).
34.....	1932...	V.....	Frame was essentially intact with no apparent damage.

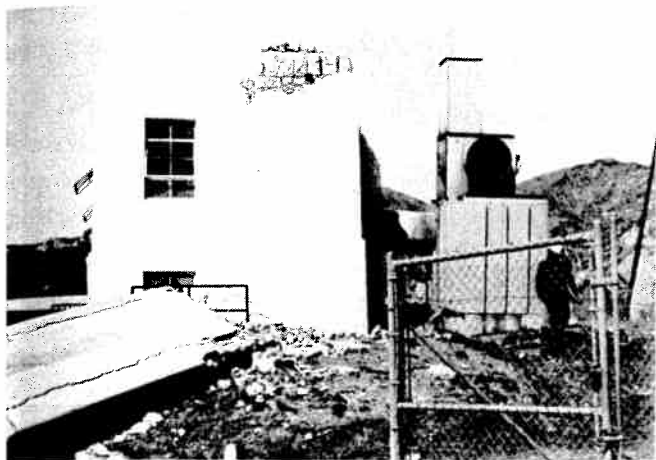
Figure 26.—Veterans Administration Hospital, Unit 44.  
East elevation.

44.....	1949...	II.....	Frame was essentially intact. Some walls had diagonal hairline cracks. Chimney was collapsed (fig. 26).
45.....	1949...	II.....	Frame was essentially intact. South wall had a diagonal crack. North brick filler wall had several cracks and was bowed outward. Brick boiler walls had several large fractures with horizontal displacements (figs. 27 and 28).

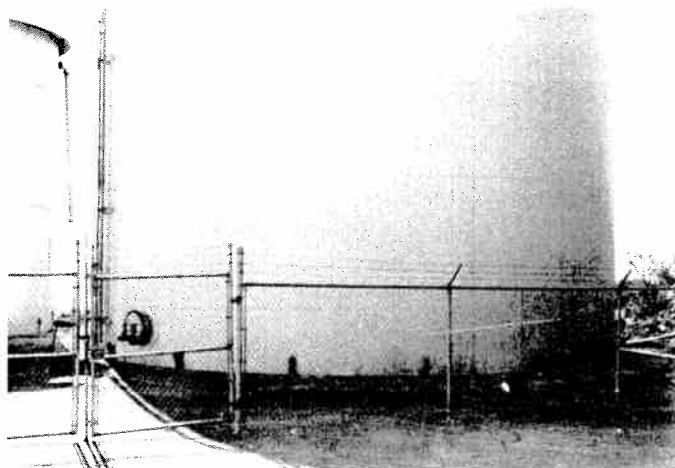
Figure 29.—Veterans Administration Hospital, Unit 47.  
North elevation.

47.....	1949...	Metal tank.	Tank was essentially intact. Slab-on-grade at anchor bolts had short hairline cracks. Water seepage was observed at the base (fig. 29).

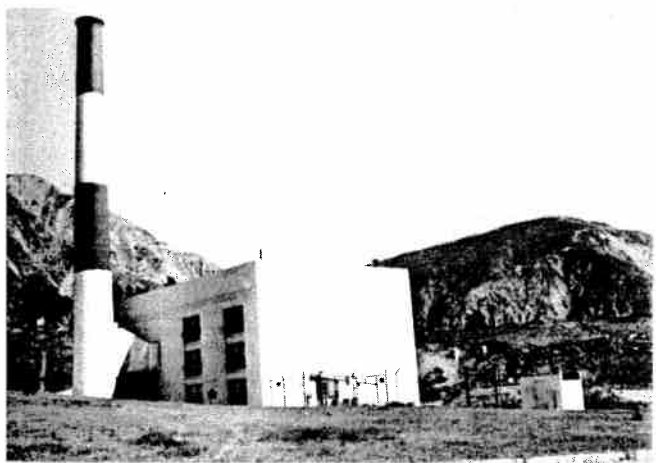
Figure 27.—Veterans Administration Hospital, Units 45 and 49.  
South elevation.

49.....	1949...	Chimney with reinforced concrete wall.	Chimney was essentially intact. Wall had continuous horizontal hairline cracks at approximately 20 feet center to center, probably at construction joints. 2-inch downward displacement of adjacent grade was observed on north side (fig. 27).

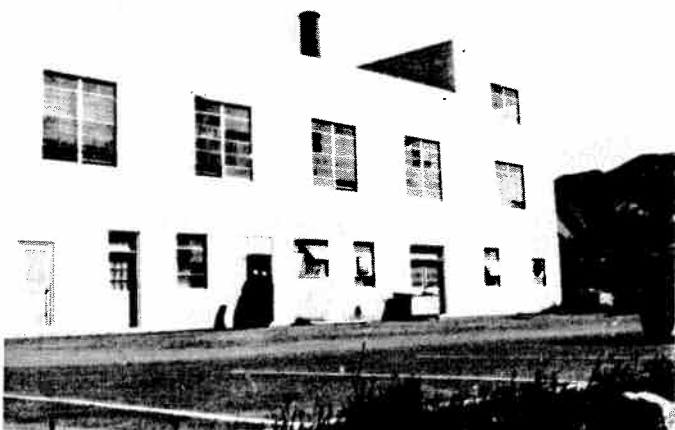
Figure 30.—Veterans Administration Hospital, Unit 50.  
South elevation.

50.....	1951...	II.....	Frame was essentially intact. South exterior wall had horizontal hairline cracks at top and bottom of piers between window openings. Interior basement walls had diagonal hairline cracks. 1- to 6-inch downward displacement of adjacent grade was observed on north and east sides (fig. 30).

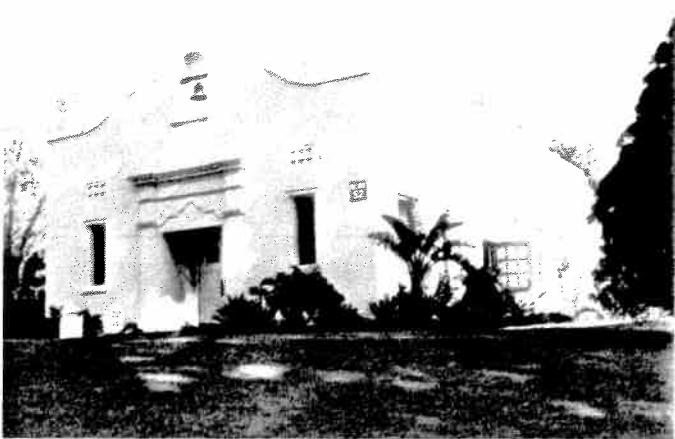
Figure 31.—Veterans Administration Hospital, Unit 52.  
West elevation.

52.....	1951...	II.....	Frame was essentially intact. No apparent damage was observed (fig. 31).
53.....	1950...	II.....	Frame was essentially intact. No apparent damage was observed. Exterior mechanical equipment (water filters) was displaced and pipes were broken (fig. 32).

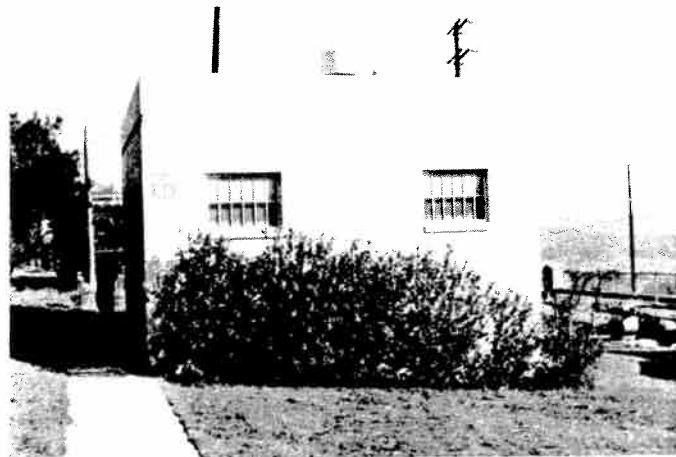
*Figure 33.—Veterans Administration Hospital. Unit 54.  
West elevation.*

54.....	1950...	II.....	Frame was essentially intact. No apparent damage was observed (fig. 33).

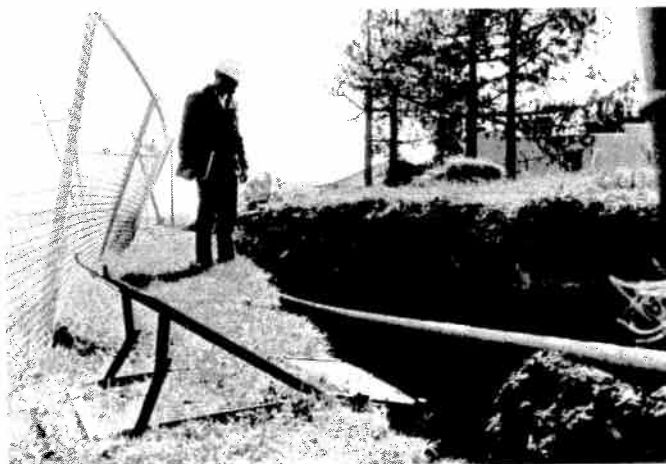
*Figure 35.—Veterans Administration Hospital. Earth slippage  
along hilltop north of units 8 and 10.*

Although some hillside earth slippage was observed (fig. 35), the building failures were precipitated by intense areal ground motion rather than localized earth faulting or permanent ground movements. An examination of the data in table 2 reveals that, for the most part, the 26 buildings and additions constructed prior to 1933 sustained the greatest structural damage. Four of these buildings totally collapsed during the initial moments of the main shock, and the remainder, with the exception of unit 29 (paint and oil storage building, fig. 21) and unit 34 (greenhouse), are in various stages of deterioration. Of the two ancillary structures built prior to 1933, unit 20 (water tank, fig. 18) incurred substantial damage to the support beams and foundations, but unit 40 (automatic valve chamber) experienced no observable structural damage.
